Fish Passage in the Tasman District

Update report

May 2006

This report provides results of a survey of culverts, bridges and flapgates in coastal Tasman and Eastern Golden Bays to assess the extent of restriction or impedance to passage of fish to and from the sea. A summary of the fish barrier inventory is also provided.

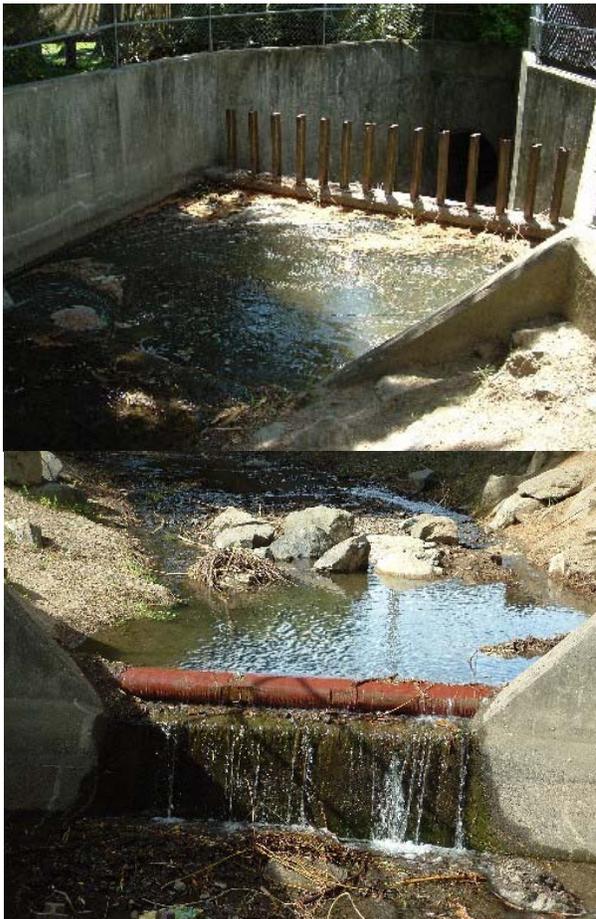
Figure 2: Reservoir Creek, Marlborough Terrace Easby Park.

Figure 2 and Figure 3 are examples of concrete structures which are acting as fish passage barriers due to a number of factors, but in particular the limitation of flow and vertical height differential.

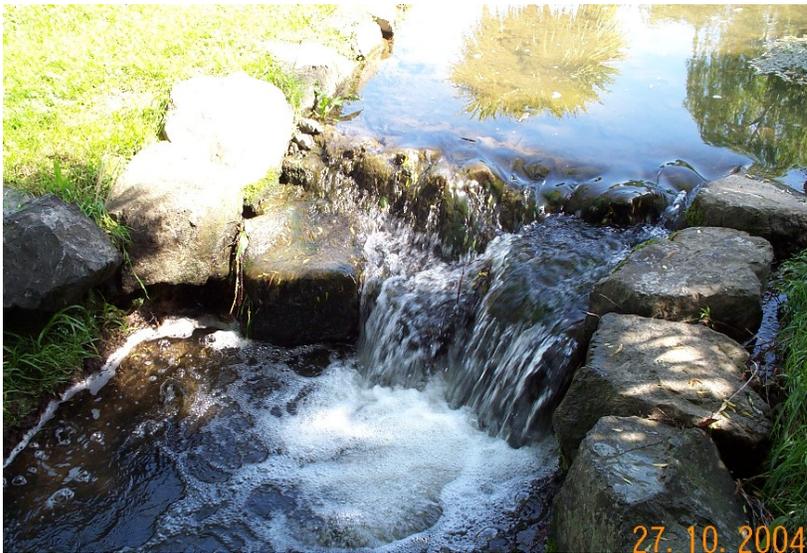
Figure 4 Reservoir Creek Rock structure, Near Salisbury Rd.

Figure 4 is an example of a riprap rock structure which has been placed in-stream to increase water level above to form a pond. As the wetted surfaces are very undercut at low flows this becomes a fish passage impedance for small fish with poor climbing ability such as Inanga. In this particular case the pond formed is also a potential thermal barrier due to the shallow un-shaded nature of the pond created behind it.

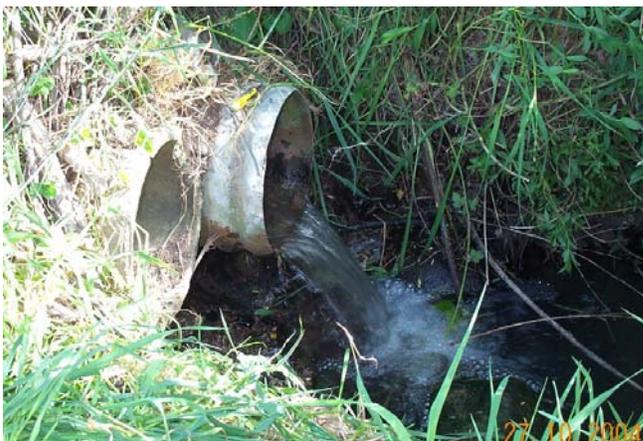
Figure 5: Reservoir Creek Culvert, tributary Kareti Dr (now removed).

Figure 5 is an example of a culvert which is a fish passage barrier due to its vertical height above the creek and its overhanging nature. This particular structure has since been removed in a redevelopment.

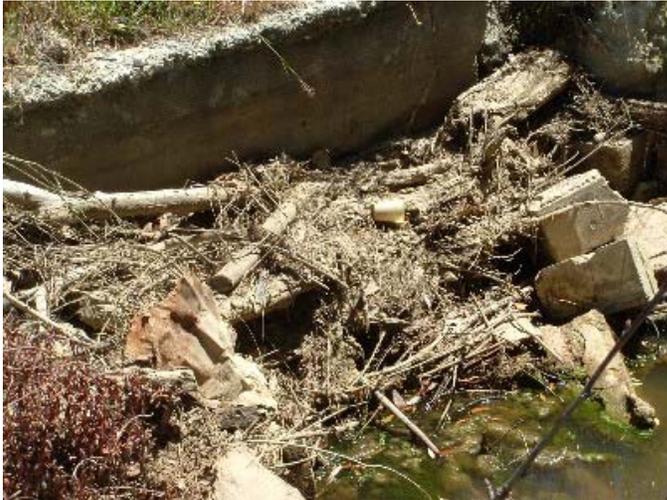
Figure 6: Kaiteriteri inlet, wetland outflow.

Figure 6 is an example of a culvert which is poorly maintained and is dilapidated to a state that it has become a fish passage impedance. This particular culvert also inhibits flow limiting the wetland behind it from being flushed.

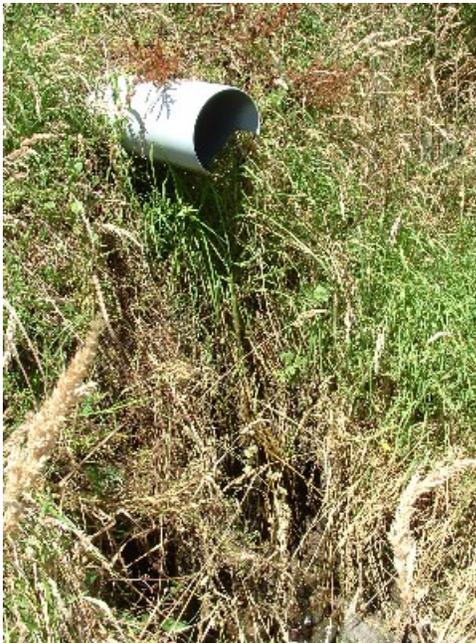
Figure 7: Reservoir Creek, Walkway

Figure 7 and Figure 8 are examples of culvert pipes which have a large vertical drop creating a fish passage barrier, due to the distance from the creek bed. These particular examples have a low flow during dry periods; the upstream habitat is an important feature to take into account when considering improving fish passage.

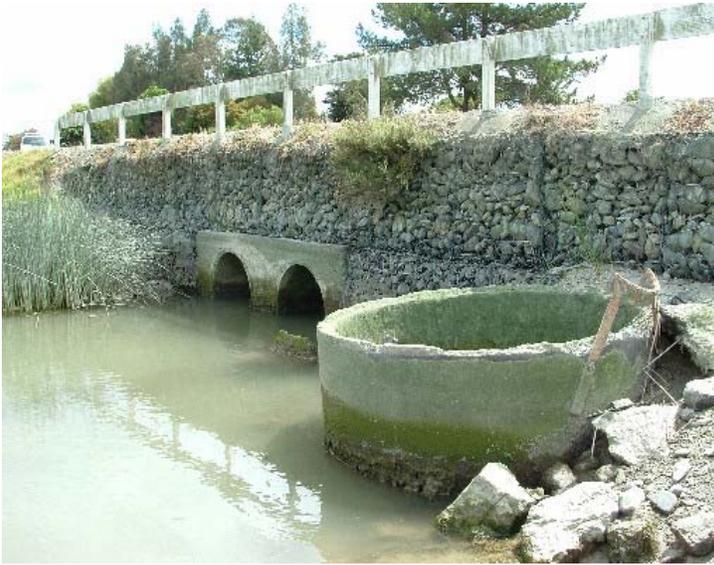
Figure 9: Nieman Ck, Queens St

Figure 9 is an example of a culvert system which is a fish passage impendence due to flow velocity in the culvert pipes. If flow velocity exceeds 3.5 ms^{-1} it is considered a potential barrier for fish passage. In this example the culverts are considerably narrower than the creek width creating the problem associated with flow velocity. This is only a barrier for 2- 4 hours at near-low tide. Fish gather below the culvert trying to move upstream and are then vulnerable to predation.

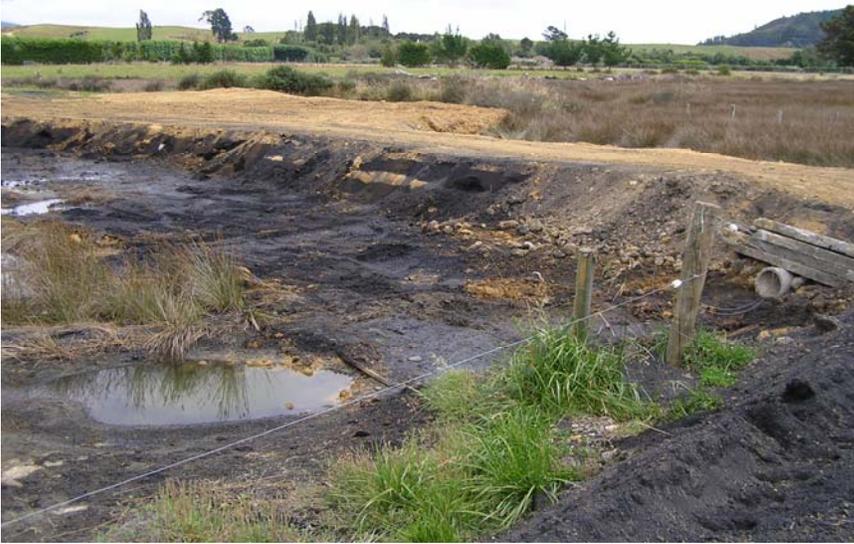
Figure 10: Farm crossing near the Motupipi Inlet, Golden Bay.

Single barrel culverts, such as shown in Figure 5 and 10 are the most common type of fish barrier, typically due to the overhang at the downstream end but also from high water velocity.

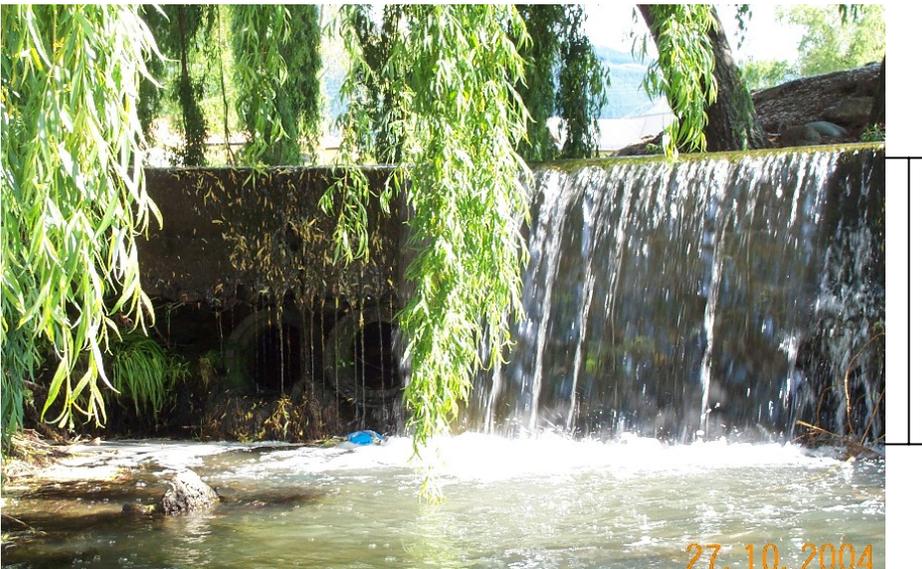
Fords can create large restrictions on water flow and fish passage (Figure 11), these can occur in both urban and rural environments. Forestry fords have been identified as a potential fish passage barrier problem (Figure 12).

Figure 11: Reservoir Creek Concrete Ford downstream Templemore Pond – Removed in 2005 (Scale 1.0 m).

This structure is due for removal in mid 2005.

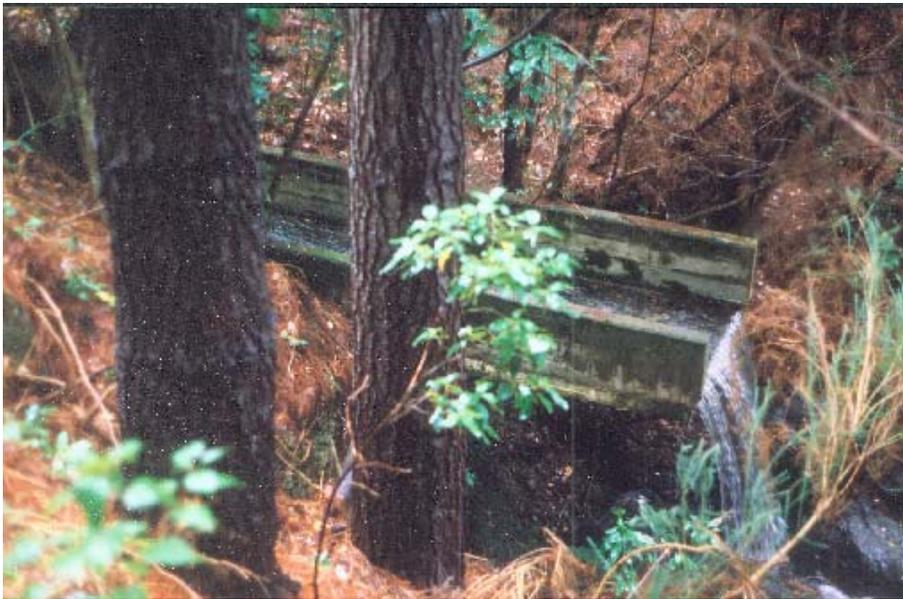
Exotic Forests have many roads; many of these have structures which restrict fish passage due to poor design. Culverts and Drains can provide restricted fish passage access to waterways and creeks. Figure 13 is an example of a forestry culvert which is restricting fish passage.

Figure 13: Example of a forestry culvert acting as a barrier to fish passage.

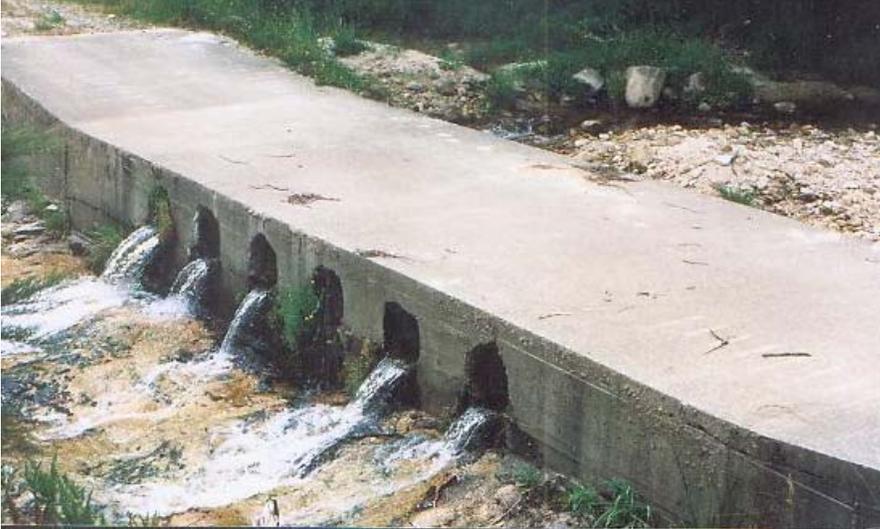
Figure 14: Ford at Dart River, Wangapeka

Multi barrelled culvert bridges (Figure 14 and 15) can pose a potential Fish passage barrier for different reasons; flow velocity, blockage, Perched and overhanging heights.

Also having a concrete apron attached makes a shallow wide shelf which can inhibit passage by jumping fish which need to obtain thrust from deeper water. New designs are available which try to limit these factors e.g. Baigent Bridge.

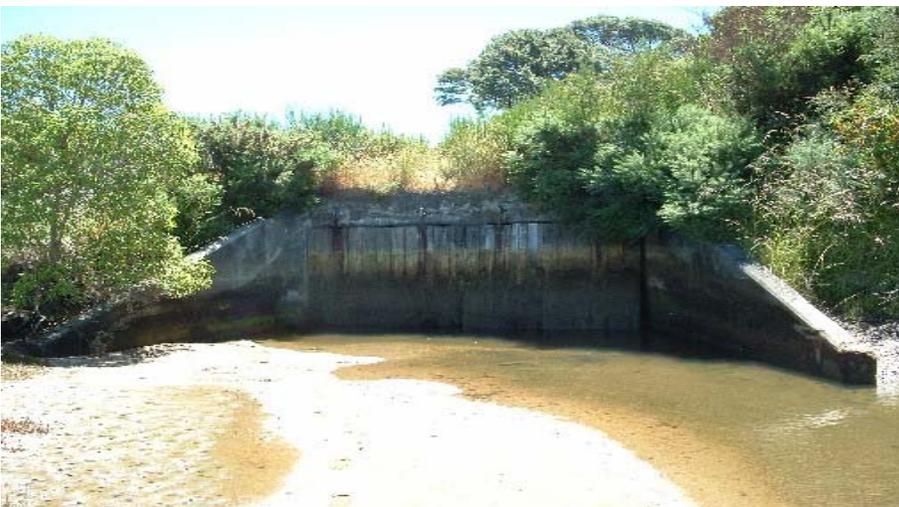
Figure 17: Wai Atua Stream Tidal Flap gate.

Coastal structures such as tidal flap gates are potential fish passage barriers (Figure 17). The Engineering department has provided an inventory of known coastal tidal flap gates which will be surveyed as part of this ongoing project. There are 28 known and maintained tidal flap gates owned by the TDC, the majority of these structures are in the Waimea, Motueka and Riwaka coastal areas.

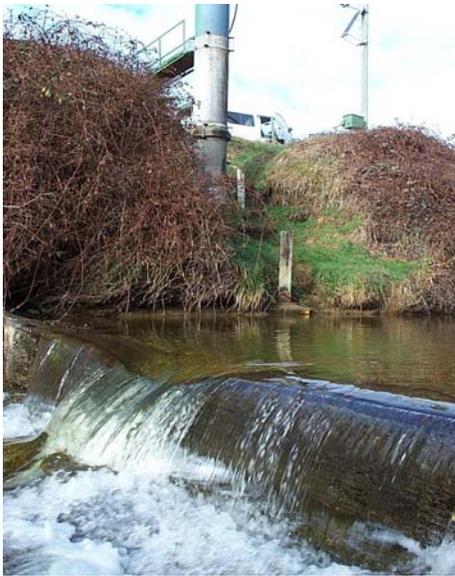
Figure 19: Tadmor River, TDC Hydrology weir

Within the region a number of river flow measuring sites utilise weirs that are potential fish passage barriers or impedances (Table 2), these structures can be easily retro fitted to minimize the impact that they have on fish passage. Figures 18 and 19 are typical flow measuring weirs which can impede fish passage due to flow velocity and vertical drop. There are 14 of these structures known to the TDC in this region.
