# **Assessment of Affects on Fish Passage at Tide Gates Using DIDSON Technology**

Prepared for  
Tasman District Council

Strickland R, Quarterman A 2007. Assessment of Affects on Fish Passage at Tide Gates Using DIDSON Technology.  
Prepared for Tasman District Council. Cawthron Report No. 1260. 12 p.

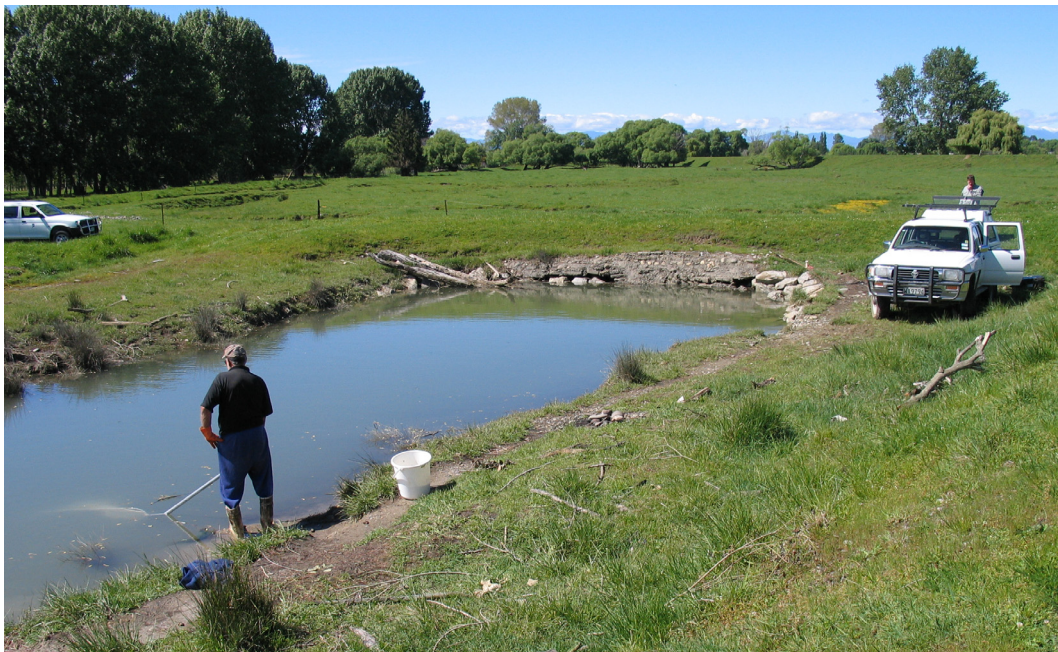
**Figure 2.** Small tidal arm in the Motueka estuary draining DOC owned reserve. Whitebaiting was occurring within 20 metres of the tide gate.

Apart from increasing whitebait vulnerability to predators, the tide gate appeared to have negligible effect on whitebait passage for most of the seven hours that the gate remained open, as there was a steady stream of whitebait exiting the top end of the culvert. Given the number of whitebait successfully reaching the remnant parcel of wetland above the culvert, there appeared to be insufficient habitat and protection for these fish to grow on to maturity. There

is a lot of scope for improving the remnant wetland and increasing its potential as rearing habitat.

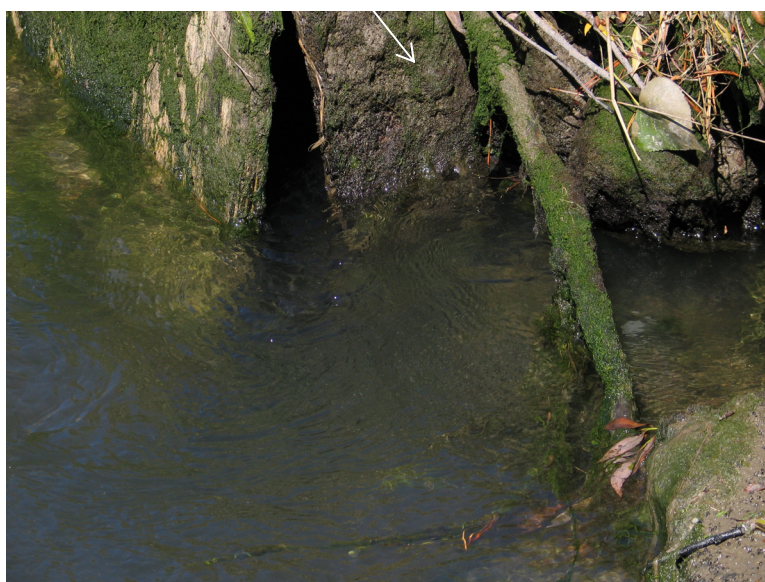
During normal flows the Motueka tide gate holds back very little water from the upstream catchment so that on the dropping tide, gate opening is gradual and the gate remains in a partially open state for just over seven hours (Figure 3). During half tide conditions the flow through the culvert is slow as is the small stream draining the wetland.

**Figure 3.** Motueka tide gate remains open even at half tide height, allowing about four to six hours on every tide cycle for whitebait to negotiate the culvert.

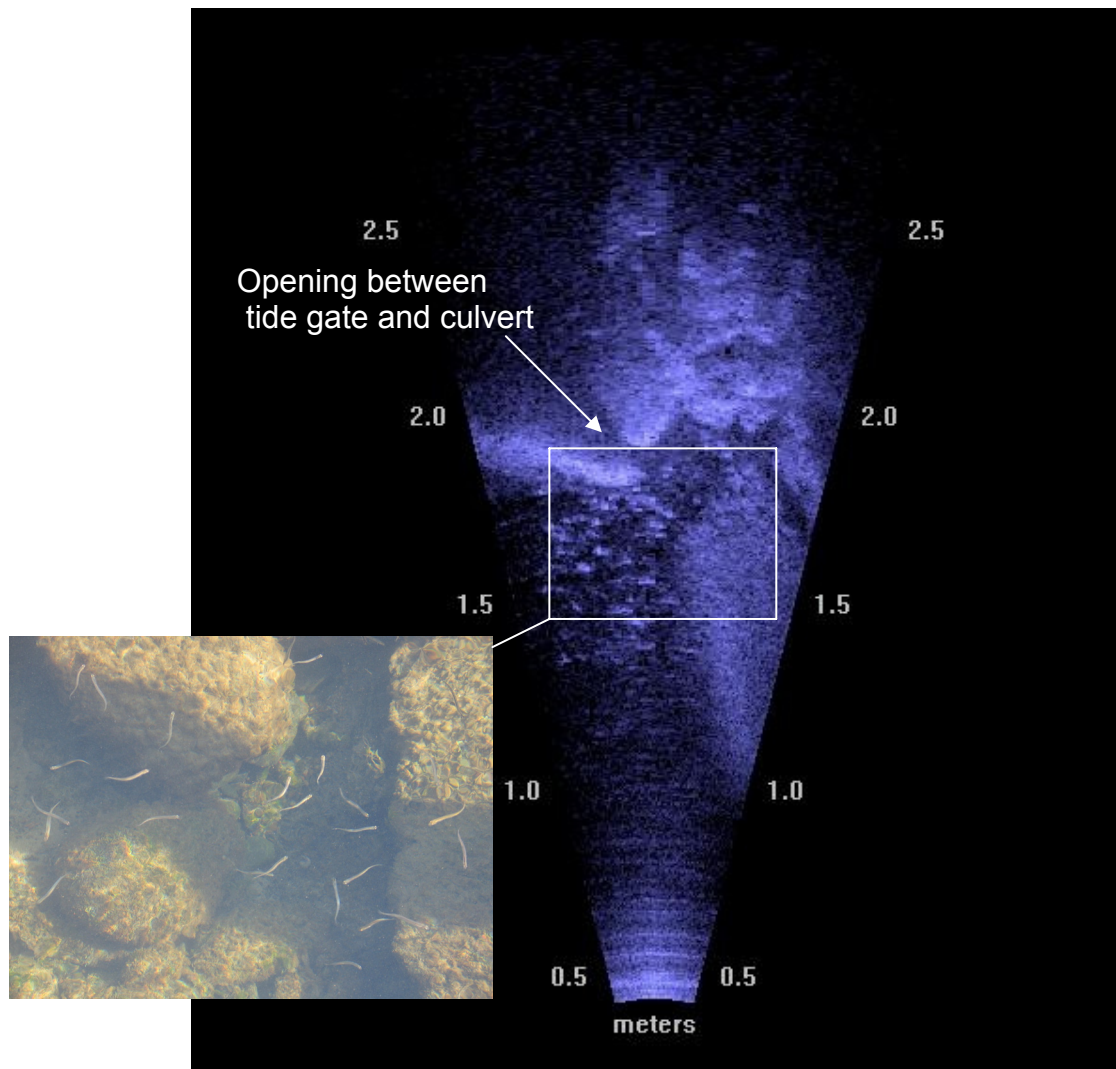
The DIDSON was set up about two metres from the tide gate at an angle sufficient to allow monitoring of fish behaviour through one side of the gate (Figure 4).

**Figure 4.** DIDSON underwater plan view of the Motueka tide gate taken of and at the same angle as the image in Figure 3. Inset is actual plan view photo of whitebait congregating at the tide gate entrance.

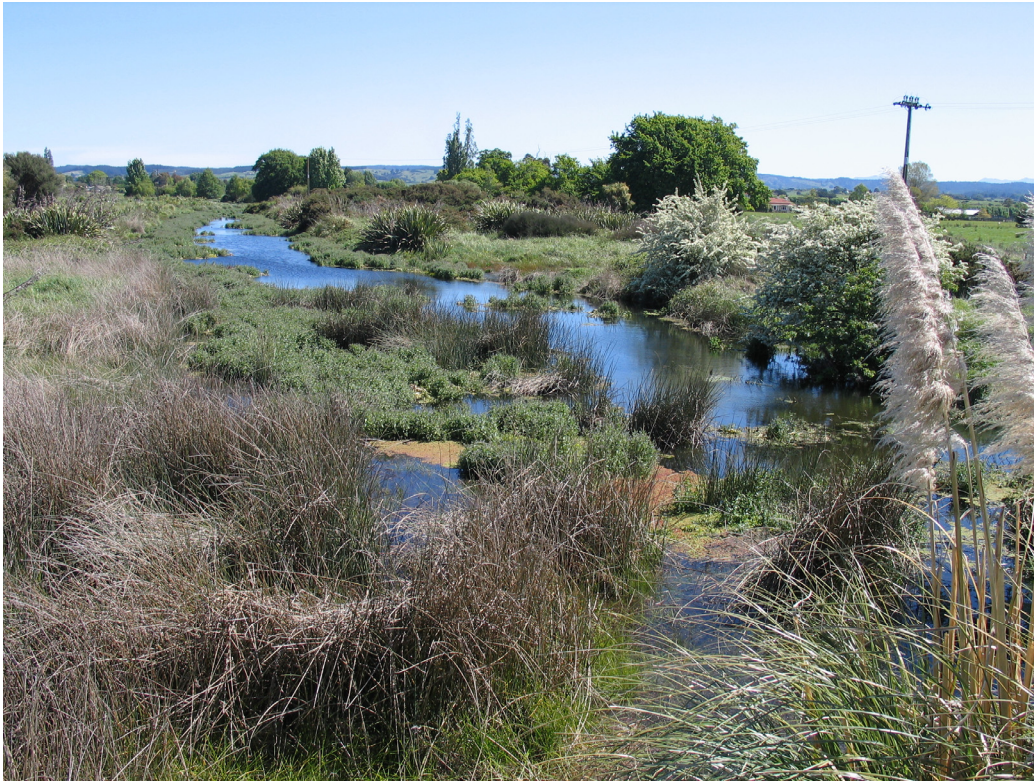
Pearl Creek discharges into the Waimea estuary through a tide gate that drains an important wetland (Figure 5) that is home to several whitebait species including the rare giant kokopu.

**Figure 5.** Wetland and backed up water created upstream of the Pearl Creek tide gate.

Upstream of the tide gate, Pearl Creek offers good rearing habitat for whitebait and other species, but needs better fish access into and through it to ensure it is fully utilised. The gate itself remains open for a sufficient amount of time during each tidal cycle to allow fish access. The main issue to deal with is the effect of velocity through the culvert and tide gate. There are several ways of overcoming this issue, but on-site discussion with an engineer to work through what is practical and feasible is required before recommendations can be made.

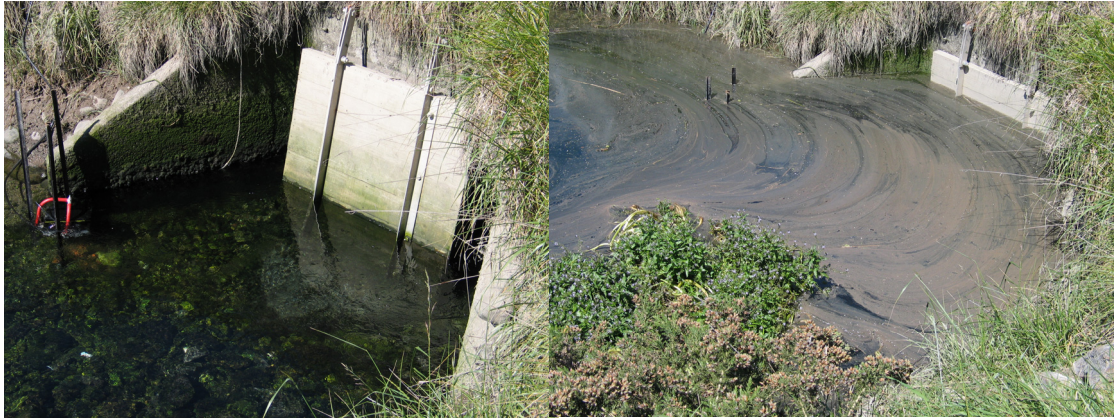
A substantial flow in the creek causes water to back up through the lower section of the wetland when the tide gate closes at high tide. The gate remains closed for about three and a half hours and open for about eight and a half hours on each tidal cycle (Figure 6). Due to the flow in the creek and the water that is impounded during gate closure, a steady velocity above 0.3 metres/sec is created through the gate and possibly persists through the culvert.

**Figure 6.** Pearl Creek tide gate open at low tide (left) and closed at high tide (right). DIDSON is mounted between three waratahs at left of frames. On the tide monitored, water eventually covered the top of the waratahs and the tide gate.

From the images and measurements obtained with the DIDSON, combined with our observations above the culvert, it appears that water velocity generated through the culvert and the opening at the gate is more than whitebait can cope with. Despite this a small shoal of whitebait was observed on the upstream side of the culvert. However this small shoal pales beside the thousands of whitebait that were observed accumulating below the tide gate.

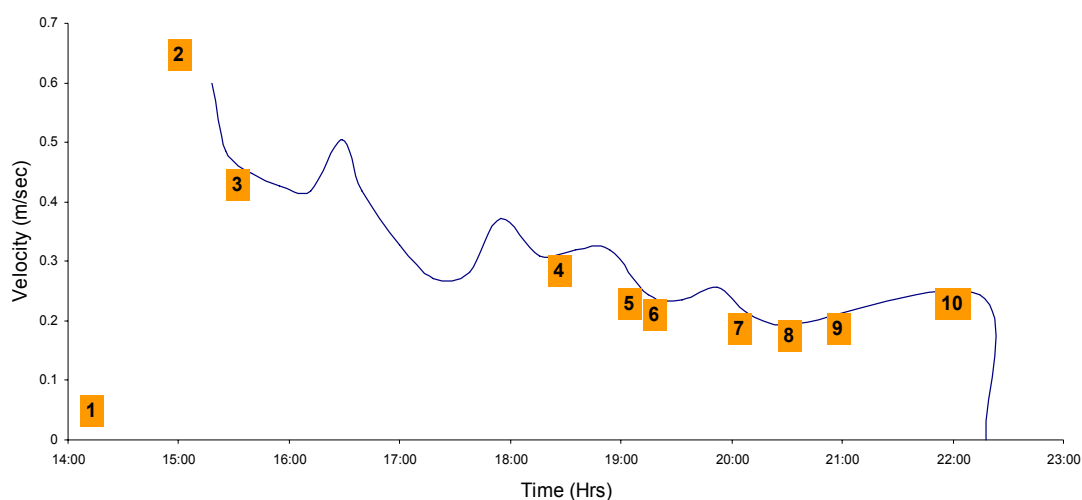
Code	Hours	Comments
1	1421	Gate open, Some whitebait going through opening on DIDSON image and then observed coming out other end of culvert (shoal of approx 50-80).
2	1500	Velocity through opening appeared to have increased and bait attempting to go through the gap were being pushed back out. Velocity measurements from DIDSON unable to be measured until 1518 hours because not positioned properly.
3	1530	Velocity slowed enough to observe whitebait making it through the gap and small shoals observed exiting top end of culvert through until gates closed at 2218.
4	1830	Gate still open, water flowing out.
5	1905	Smaller numbers of whitebait still milling around gate, few getting through gate.
6	1911	Larger fish seen at gate (seem to be galaxiids).
7	2006	More larger fish seen at gate (DIDSON), gate still open, flow slowing (gap decreased), shoals of whitebait still seen at upstream end of culvert.
8	2030	Same as previous.

9	2100	600mm eel seen at TR side of tide gate (out of view of DIDSON), small shoal of whitebait at upstream end of culvert.
10	2200	Whitebait and small galaxiids still milling around gate, eel not seen since first observation, gate still open with reasonable flow.
	2215	Gate closed.

**Figure 7.** Velocities and observations at a Motueka tide gate during October 2006.

occur can be calculated from each of the graphs. Based on this, the Motueka tide gate allowed about a four hour gap after 1900 hours until gate closure, though bank-side observation determined successful whitebait passage began at 1530 hours until closure. This was probably due to the slow velocity through the culvert.

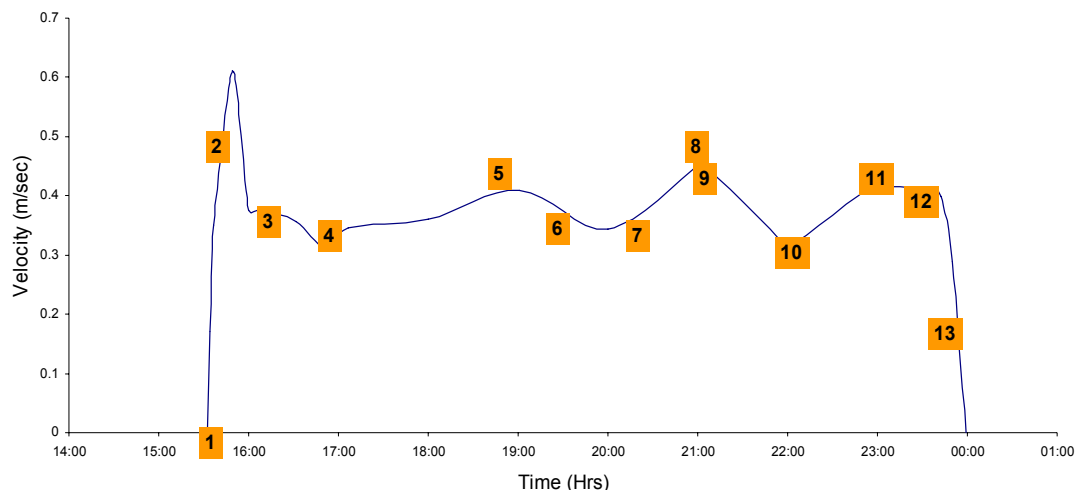
Code	Hours	Comments
1	1533	Gate opens, velocity steadily increasing. Whitebait accumulate in corner of culvert and occasionally attempt to head into the culvert but don't appear to cope with the velocity.
2	1543	Gate fully open.
3	1620	No whitebait appearing at the upstream end of culvert.
4	1700	Flow still too strong above and below culvert to allow whitebait passage upstream – still bundled up at downstream entrance.
5	1851	Dog in water near DIDSON.
6	1927	Whitebait seen 3 m downstream of gate, none observed above gate.
7	2023	Whitebait starting to accumulate around gate - flow still seems too strong for them to go through the gate.
8	2100	Eel passes through the gate (heading downstream).
9	2109	Still a lot of flow through gate, no fish seen in DIDSON.
10	2211	Gate still open, large fish splashing downstream approx 15-20 m.
11	2303	Large eel goes downstream through gate.
12	2331	Large eel goes upstream through gate.

13	2354	Gate beginning to close.
	0000	Gate closed.

**Figure 8.** Velocities and observations at the Pearl Creek tide gate during October 2006.

There appears to be a lot less opportunity at Pearl Creek for successful passage. There was only about a minute at the opening of the gate when the discharge velocity was less than 0.3 m/sec. Neither DIDSON or bank-side observation was able to determine any successful passage past the tide gate, though about ten whitebait were observed at the top side of the culvert prior to monitoring.

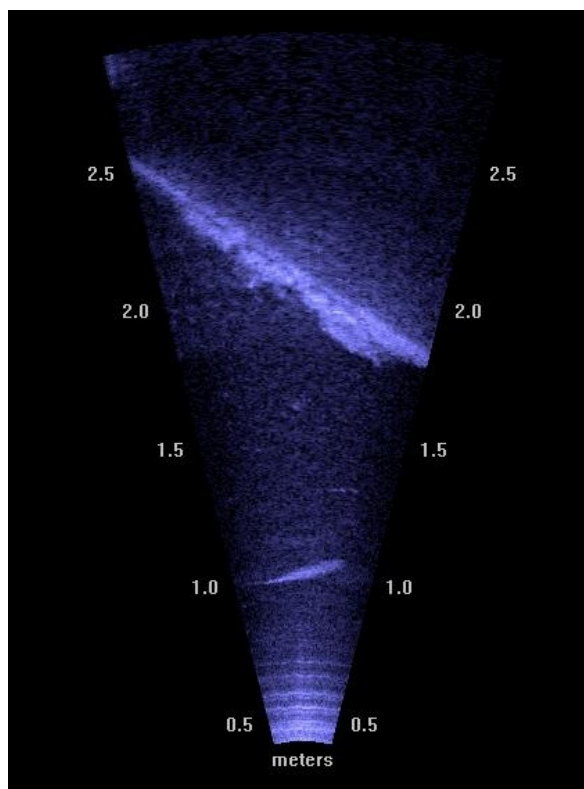
Fewer predatory fish visited the tide gates during gate closure at night. A single large fish briefly swam into view at the Motueka tide gate (Figure 9) and a small eel was active in the area for a short time but did not come into view on the DIDSON.

**Figure 9.** A 31 cm fish (either kahawai or trout) did several passes through the beam after dark at high water and during tide gate closure. Very few whitebait remained or were active in the beam after dark.
