# The Sherry River

- A Success Story

Sherry Catchment

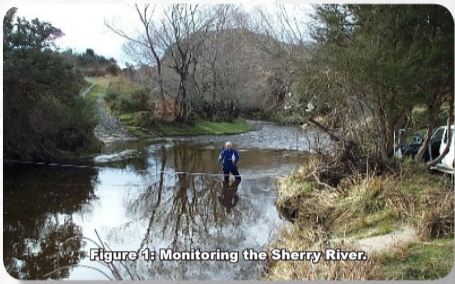
Figure 1: Monitoring the Sherry River.

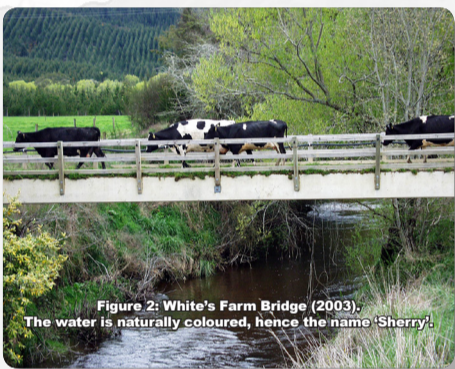
Figure 2: White's Farm Bridge (2003). The water is naturally coloured, hence the name 'Sherry'.

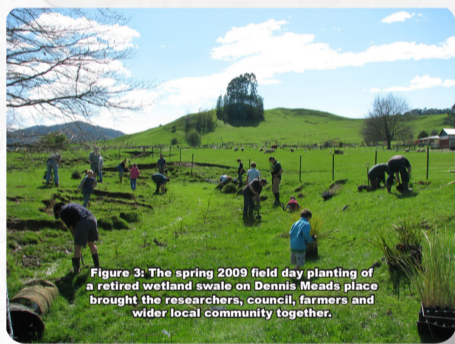
Figure 3: The spring 2009 field day planting of a retired wetland swale on Dennis Meads place brought the researchers, council, farmers and wider local community together.

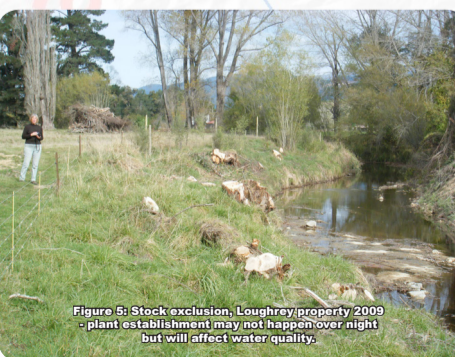
Figure 5: Stock exclusion, Loughray property 2009 - plant establishment may not happen overnight but will affect water quality.

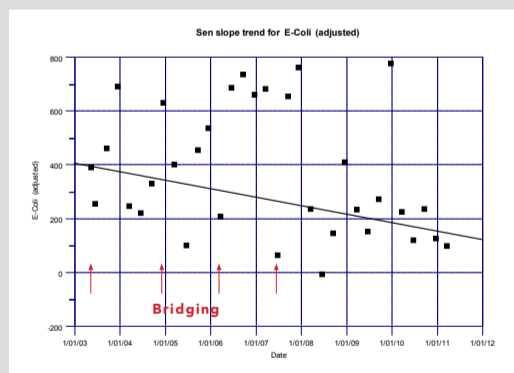
Figure 6. *E. coli* data over 8 years in the Sherry River at Blue Rock in relation to times when dairy bridges were commissioned.

- cows crossing the river - major source of water pollution
- 4 cow crossings replaced with farm bridges
- improvement in *E. coli* levels attributable mainly to bridging
- 40% *E. coli* loadings at the Blue Rock site were due to four tributaries
- further improvements are expected for other BMP's
- individual farm plans initiated the following actions:
  - riparian areas and streams fenced and planted
  - wetlands protected
  - greater awareness and stewardship by community
  - improved farm management

Using the NIWA 'Times Trends' statistical analysis package, the Seasonal Kendall (flow adjusted) test for 8 years of monthly *E. coli* data at the Blue Rock site shows a decline approaching recreational quality in 2011.
