Progress in identifying sediment sources in the Motueka Catchment

Mike Marden¹, Les Basher², James Barringer³, Steve Ferriss³ Landcare Research¹Gisborne,²Nelson, ³Lincoln

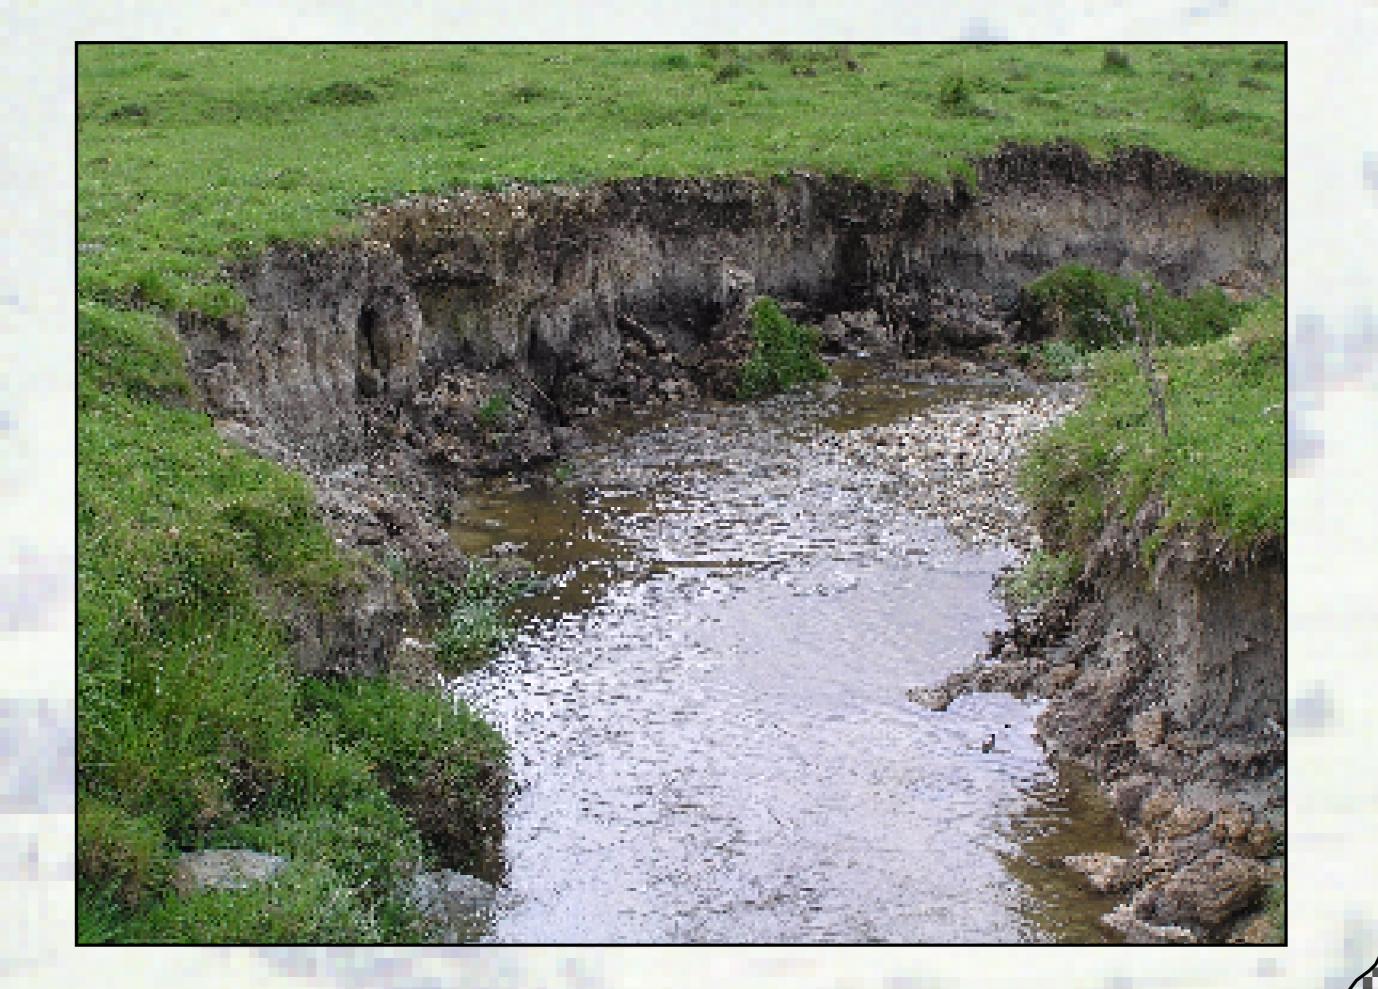
Inset: Detail of landsliding in the Upper Wangapeka Catchment. Scale 1:10,000

landslides, sheet erosion and scree (Table 1). High areal density of landsliding is restricted to one very small area (Photo 1). Gullies, landslides, and extensive bare ground subject to surface erosion by water and wind are common in the upper Motueka River (Photos 2 and 3). Bank erosion covers a small area (Table 1) and ranges from infrequent large features (Photo 4) to frequent small bank failures along many stream channels (Photo 5). Scree and sheet erosion are extensive but often not connected to stream channels. Much of the erosion occurs under indigenous forest and high-altitude tussock grassland and scrub.

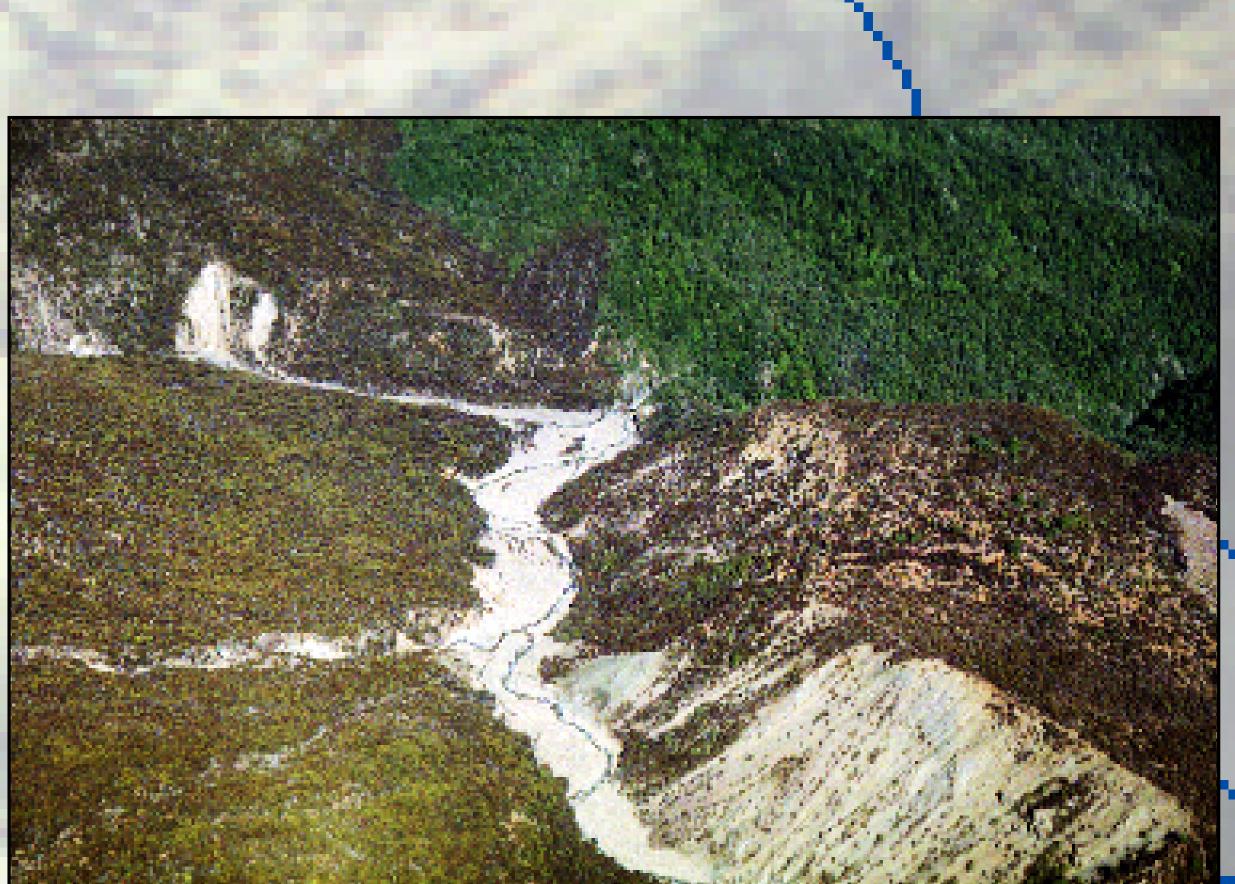
Photo 2 Active gullying, bank erosion and surface erosion in the upper Motueka

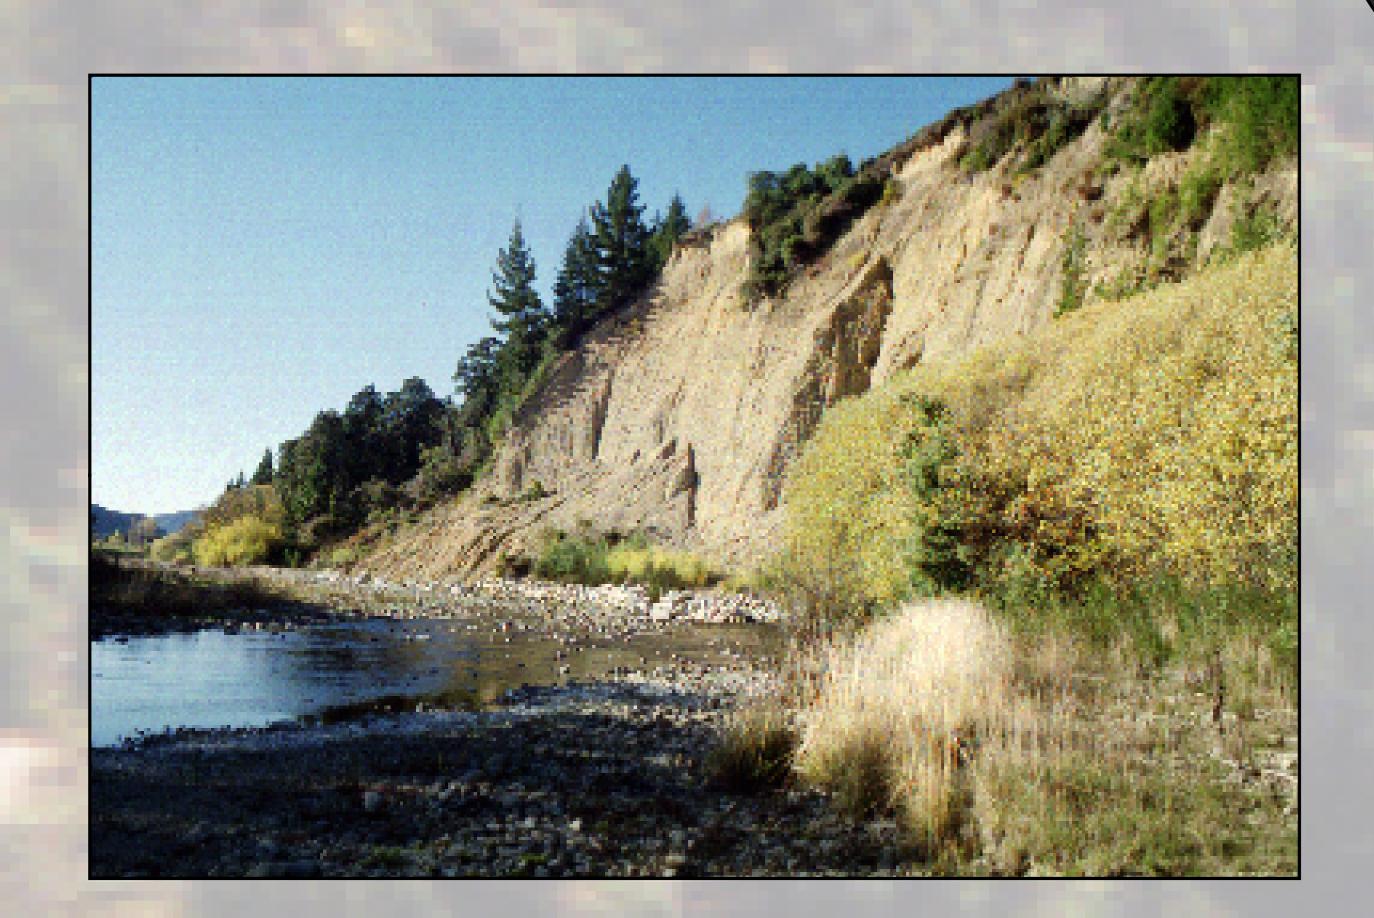
Photo 4 Severe large-scale bank erosion in the Motupiko River

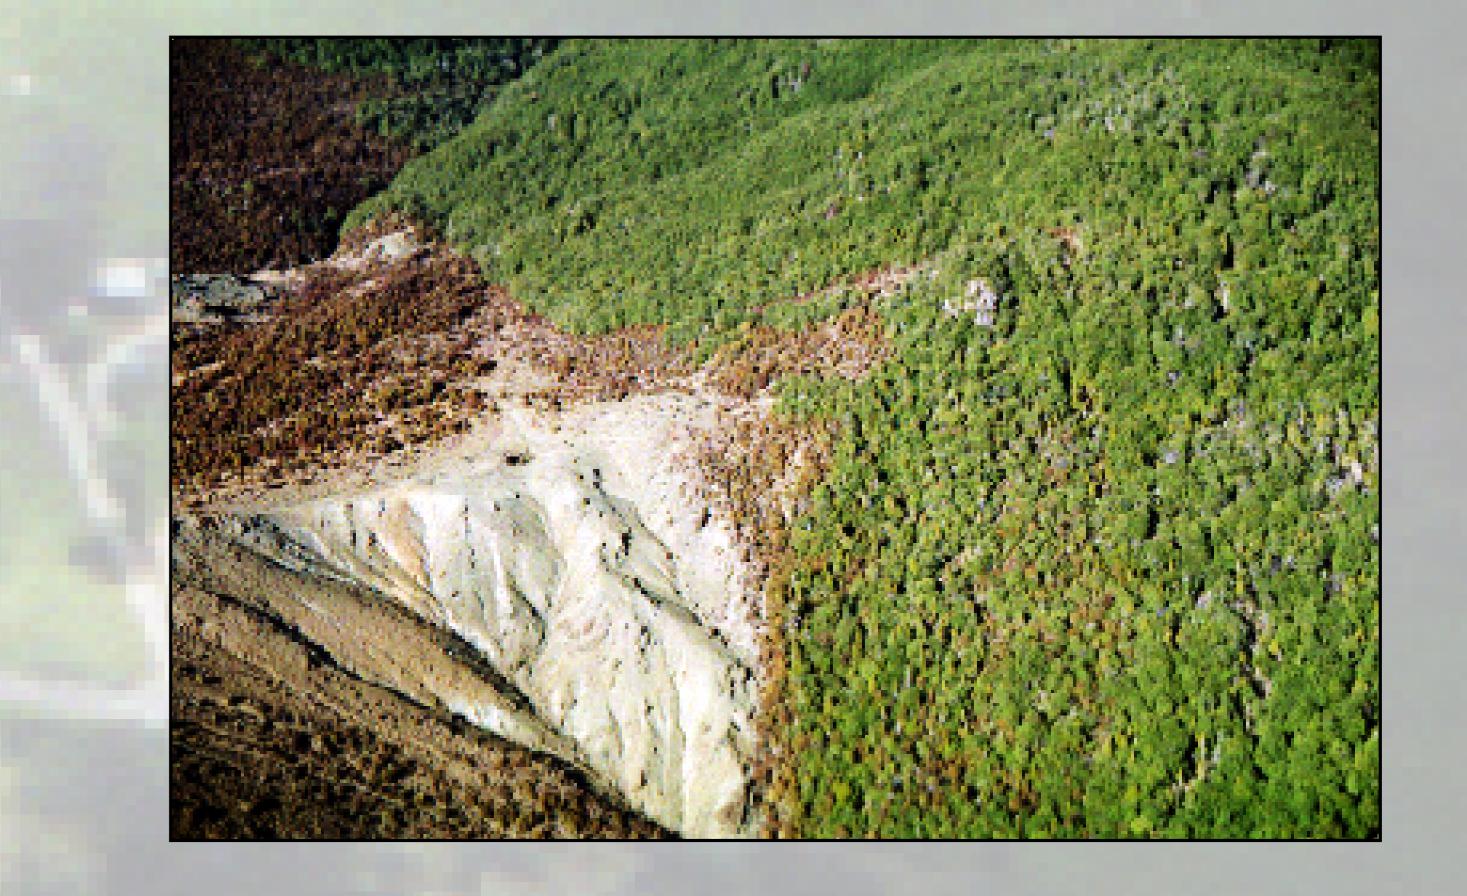
Photo 3 Severe gullying of ultramafic rock in the upper Motueka
