Fish Passage in the Tasman District

Update report

May 2006

This report provides results of a survey of culverts, bridges and flapgates in coastal Tasman and Eastern Golden Bays to assess the extent of restriction or impedance to passage of fish to and from the sea. A summary of the fish barrier inventory is also provided.

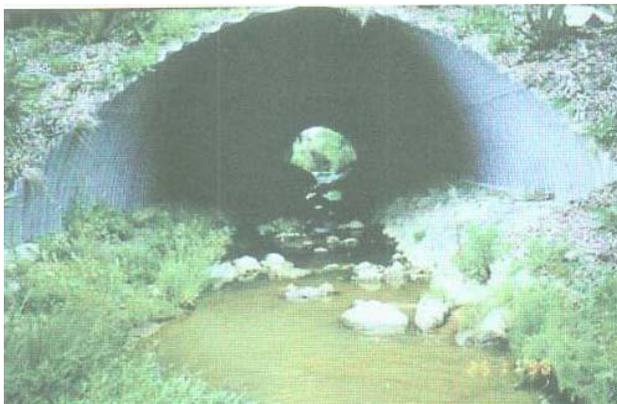
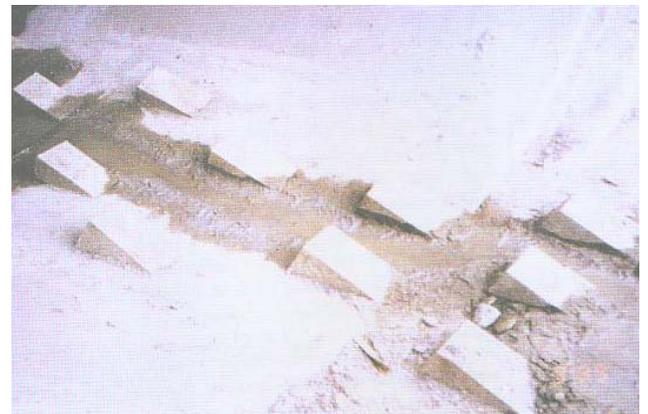
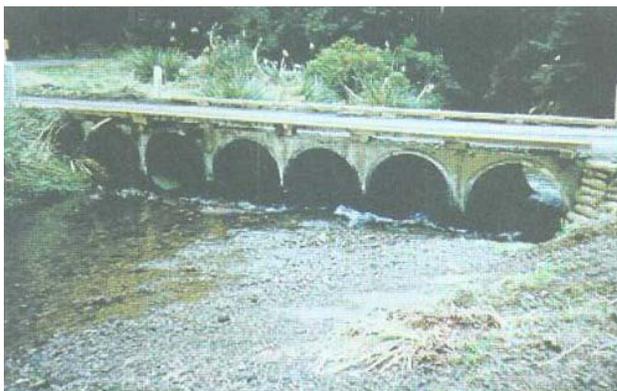
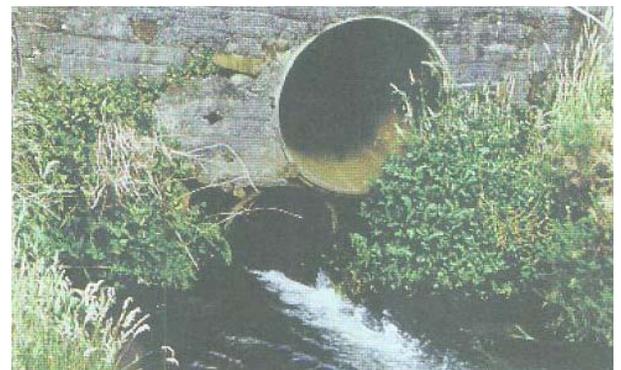
To design a new culvert or structure that allows for regular fish passage is straight forward and no more expensive than those that act as barriers. Some examples of well-designed culverts are shown in Figure 1 A, 1C & 1D below. Modification of existing structures can be achieved. For example spoilers can be bolted on to the base of the culvert (see Figure 1B).

Figure 1; A: Top left: A fish-friendly culvert showing the natural stream bed filling the base. Figure B: Top right: The use of spoilers can be used to create resting places for fish that can only sustain short bursts of swimming in high velocity water. Figure C & D: With multiple barrels some can be set deeper to ensure passage at low flows.

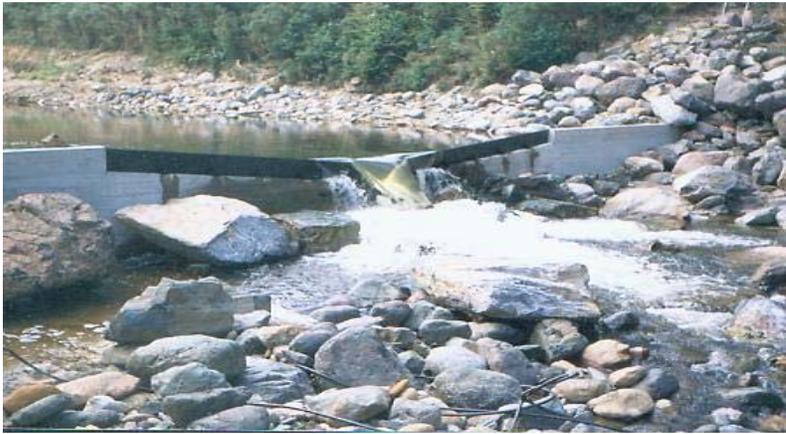
Within the region a number of river flow measuring sites utilise weirs that are potential fish passage barriers or impedances (Table 2), these structures can be easily retro fitted to minimize the impact that they have on fish passage. Figures 18 and 19 are typical flow measuring weirs which can impede fish passage due to flow velocity and vertical drop. There are 14 of these structures known to the TDC in this region.

Figure 18: Example of Hydrology Weir at the Maitai River (not in Tasman).
